Service Bulletin

Subject: 24 Port ECU Red Light Disconnect

Product Line: Recon Wireless Blockage and Flow Monitor

Document Number: 600870-000035

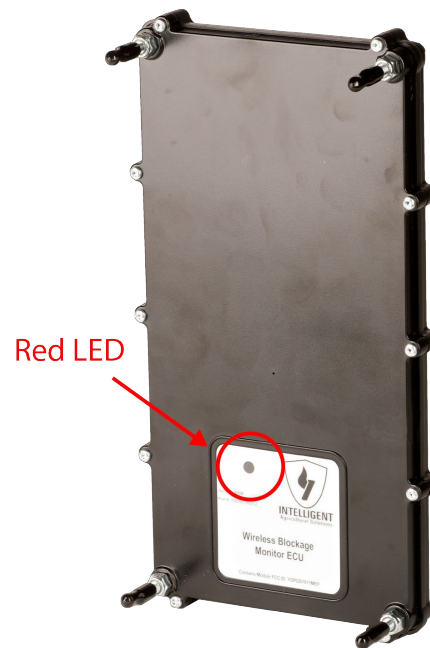
Problem Statement: In August through October 2019, Intelligent Ag received returned ECUs with a software bug that prevents the ECU from functioning. When this happens, the red LED light on the ECU is solid instead of blinking and the ECU is disconnected in the app.

Resolution: Intelligent Ag has released an app update through the Apple store which includes a firmware update for the ECU that will address this bug.

1. Download the latest Recon Wireless Blockage and Flow Monitor iPad app (version 2.5.450 or later).

2. Make sure you're connected to the IASBlockage network. Open the app, and the ECUs will update.

If the problem continues after updating the ECU firmware with the new application, contact your dealer to replace the faulty ECU with a new ECU.
